DEPARTMENT OF TRANSPORTATION

Quality Assurance and Source Inspection

Contract #: 04-0120F4Cty: SF/ALA Rte: 80 PM: 13.2/13.9File #: 69.28**WELDING INSPECTION REPORT****Resident Engineer:**Siegenthaler, Peter**Address:** 333 Burma Road**City:** Oakland, CA 94607**Report No:** WIR-025646**Date Inspected:** 30-Jul-2011**Project Name:** SAS Superstructure**OSM Arrival Time:** 1900**Prime Contractor:** American Bridge/Fluor Enterprises, a JV**OSM Departure Time:** 700**Contractor:** Zhenhua Port Machinery Company, Ltd (ZPMC), Changxing Island **Location:** Shanghai, China

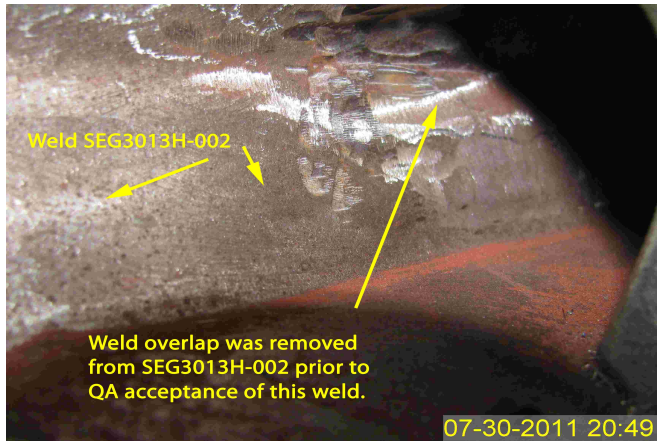
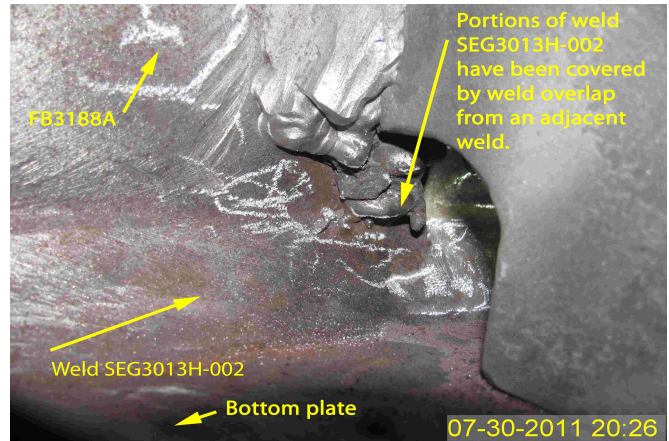
Caltrans and ABF have agreed to conduct visual and magnetic particle inspections (MT) of segment 13 West welds as part of a special inspection program. This QA Inspector observed ABF Inspectors had completed and accepted MT inspections of welds: SEG3013X-474, SEG3013E-037 and SEG3013H-002. Note: Weld SEG3013H-002 is a complete joint penetration (CJP) weld and ABF performed magnetic particle inspections on the PP119-1500 side of the CJP weld and the PP119+1500 side of this CJP weld was covered with water and no MT inspections could be performed on this side of the weld. This QA Inspector observed one portion of this weld was visually rejectable due to an adjacent weld that overlapped onto the surface of weld SEG3013H-002. This QA Inspector informed ABF MT personnel and a ZPMC worker used grinder and rotary file to remove the overlap condition. Following completion of the grinding, this QA Inspector performed random visual and magnetic particle inspection of welds: SEG3013X-474, SEG3013E-037 and SEG3013H-002 (PP119-1500 side only) and these welds appear to comply with AWS D1.5 MT and visual requirements. For additional information on these inspections see this QA Inspector's TL6028 Magnetic Particle Test Report and the photograph below.
